# Mission Inn

October 6, 2021

The subject property, constructed in phases in 1957 and 1965, is a 20,977 square foot building authorized as a tourist hotel (motel) with 52 tourist hotel rooms and a manager's residence. The subject property is located in the Excelsior Outer Mission Neighborhood Commercial District and is situated on a 26,641 square foot lot.

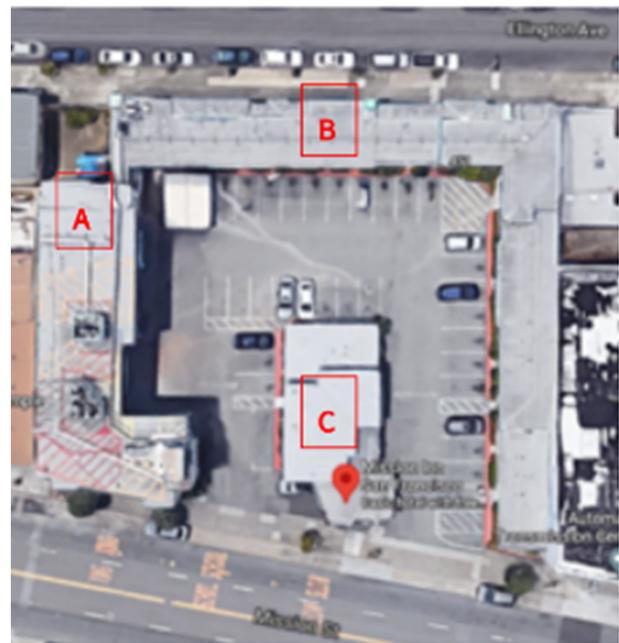
*Aerial view: Building A: Tower building at left,  
Building B: L-shaped 2 story motel at top and right,  
Building C: office and lobby building in foreground.*

1. Building A, a 24 room 4-story building
2. Building B, a two-story 27 room "L" shaped building
3. Building C, a detached two-story building situated in the middle of the lot which currently accommodates two units, a manager's unit, and a private residence with an office.

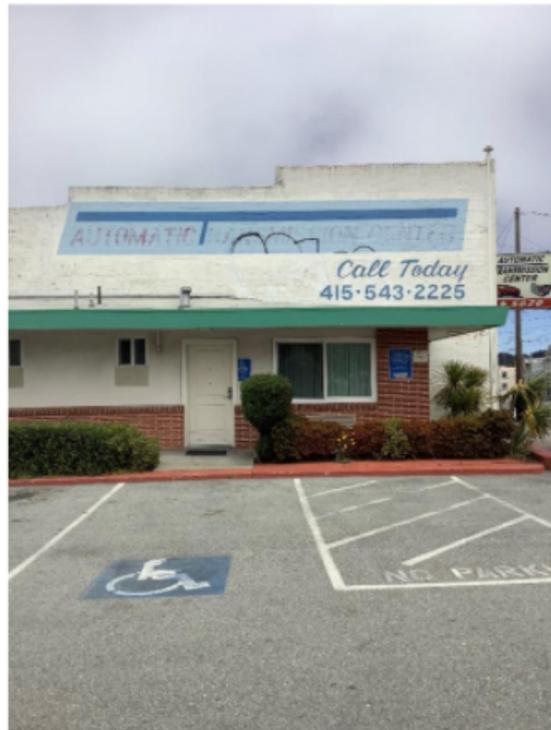
Designated Accessible Van Parking with Signage

**Accessibility:** create accessible path of travel through parking area and upgrade exterior signage; upgrade common areas accessibility features.

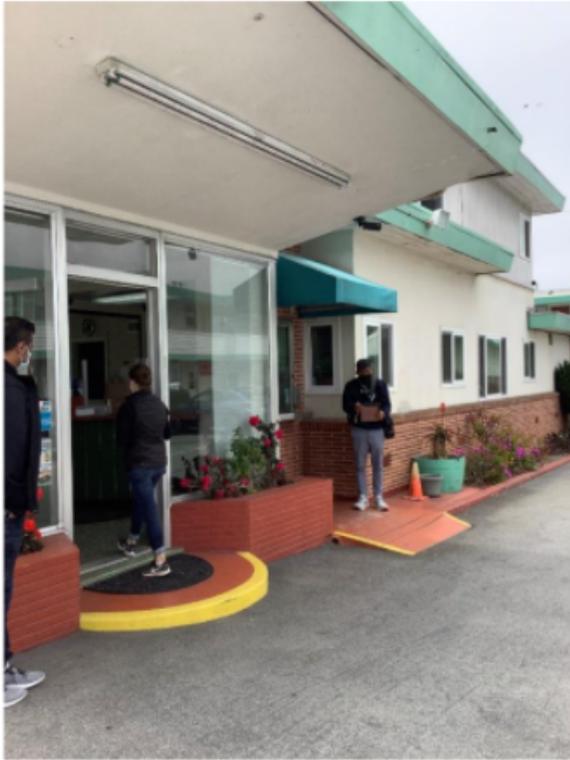
Reception/Lobby Entrance, Service Window with Ramp

- Modify pedestrian access to reception / lobby / Manager's Unit / Laundry Room to ensure ADA and California Building Code Accessibility Requirements
- Replacement of existing exterior light fixtures to new LEDs
- Create outdoor shared space by eliminating parking spaces being Management Building
- Add resident mailboxes
- Review stairs, ramps, handrails, and guardrails for accessibility compliance
- Add dedicated trash collection areas on each floor
- Replace interior finishes on elevator cab
- Replace carpet in exterior stairs with more durable finish
- Renovate 3 of 52 units to be fully ADA compliant to meet 5% threshold
- Upgrade carpet to hardwood flooring in non-renovated units; upgrade floor, paint, appliance, kitchenettes, and bathrooms in non-renovated units

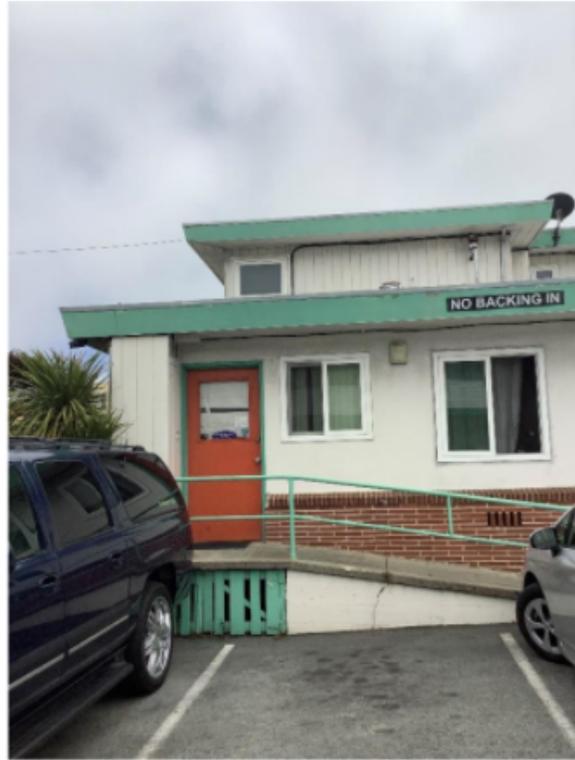
Management Building Rear Exit, Ramp

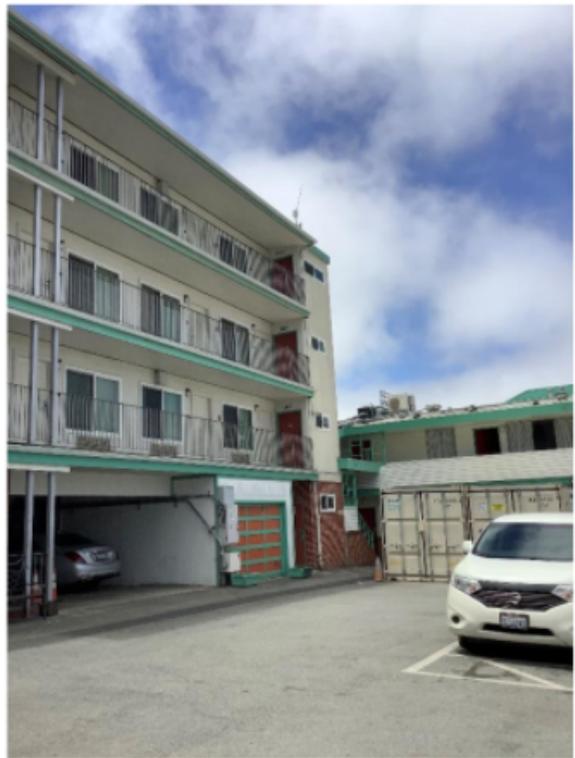
Four-story motel "tower" with Carport

- The ends of the cantilevered wood beams supporting the exterior second floor walkway at Building B are noticeably deteriorated due to water damage and dry rot.
- The guardrail at the exterior second floor walkway of the east leg of Building B is loose and deteriorated due to water damage.
- Cracking was observed in the concrete topping slab at the exterior walkways of Building A, particularly at locations where steel railings and posts are embedded in the concrete. The cracks are likely nonstructural but could pose a waterproofing issue.
- Although the Building is exempt from the City’s soft story program, Building A has a soft story condition and a retrofit is recommended. Building A is vulnerable to damage in a major earthquake due to the soft story condition.

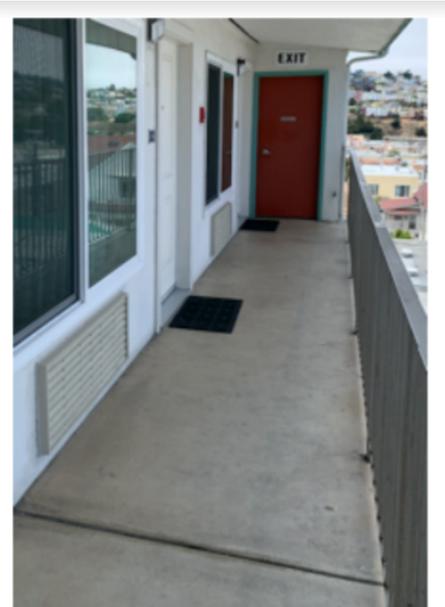
Walkway at 4<sup>th</sup> floor of Building A

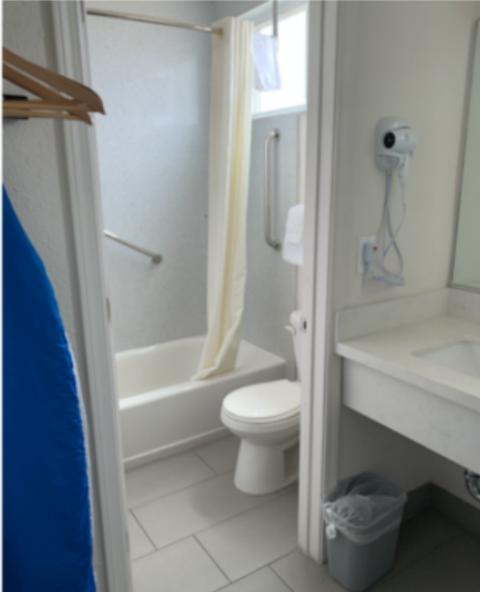
Typical built in counter, sink, and bathroom/shower room
